RIVANNA RIVER STEWARD REPORT

River Stewards: Justin Altice Date: 06-18-17

Starting Location and Time: Advanced Mills Bridge–North Fork (1:00 PM)

Ending Location and Time: 29N Bridge – North Fork (2:30 PM)

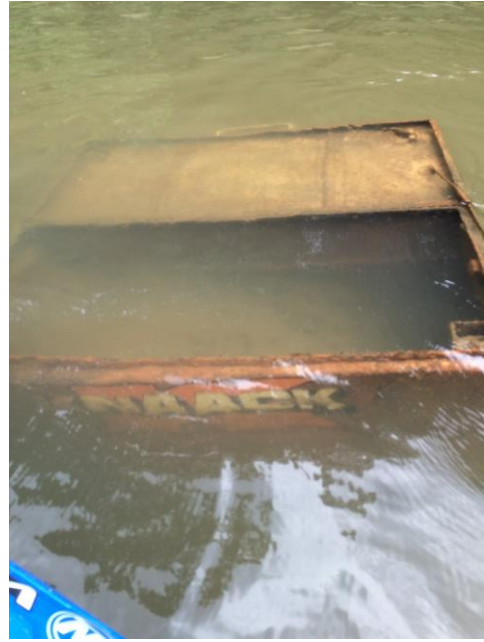
Figure 2: Large metal container near starting point.

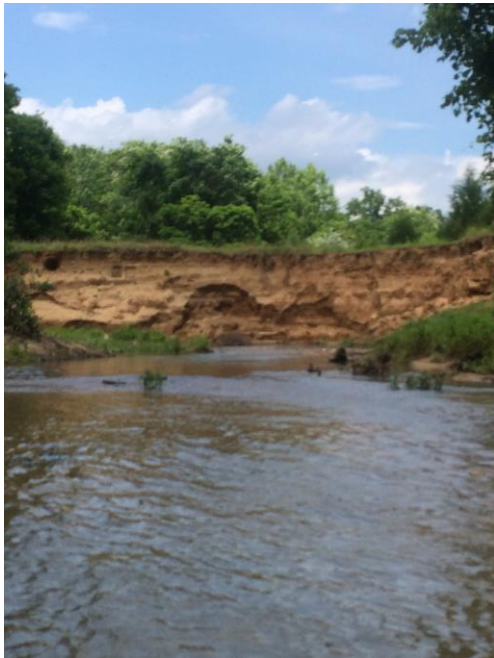
The most notable aspect of this stretch was the severely eroded banks I encountered along the way. Large mounds of the bank were in piles in several places, actively causing large amounts of sedimentation to occur. The bridge along Dickerson Road that is passed under along this route was closed due to construction, with one side being completely removed. Also observed was a River Gauge on that bridge.

Figure 3: Severely eroded bank.

2 – Work on ways to stabilize some of the banks causing the worst sedimentation through erosion.

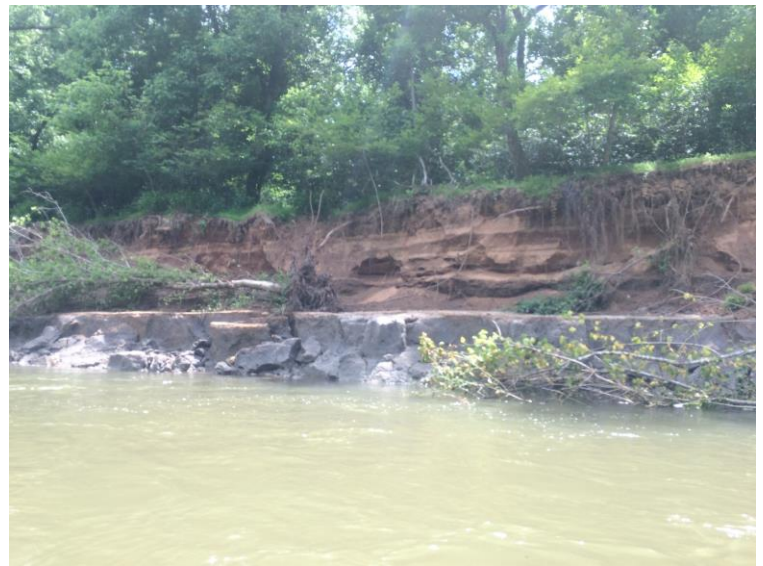
Figure 4: Sedimentation occurring from bank erosion.

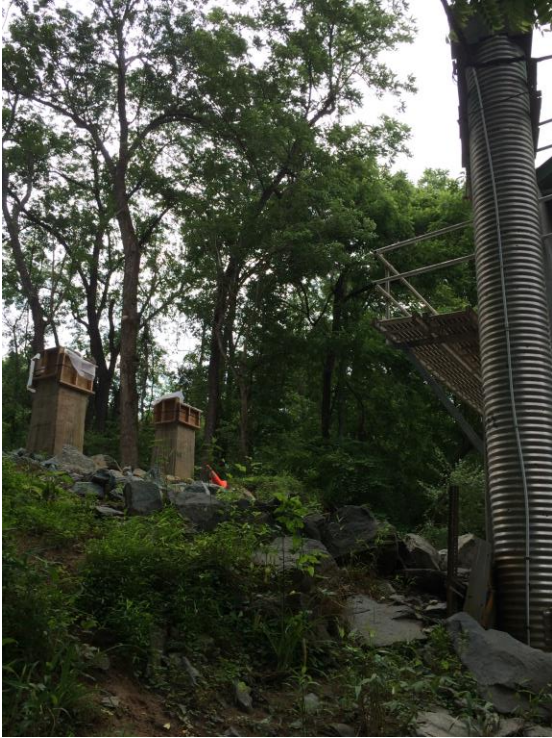
Figure 5: Dickerson Road Bridge Closure.

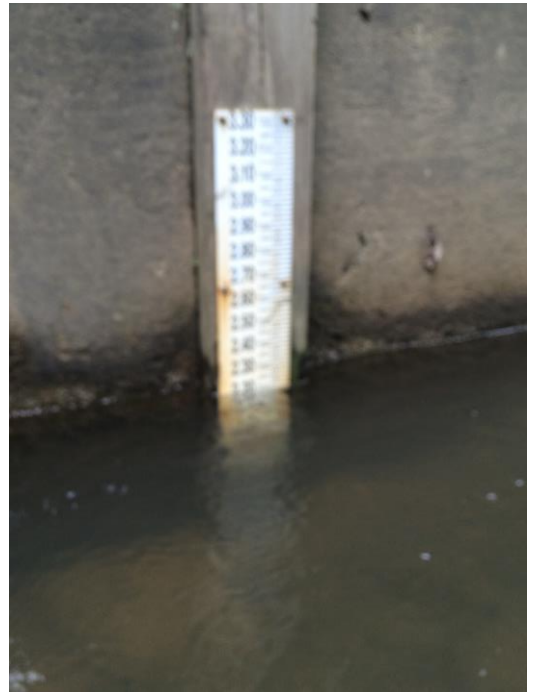
Figure 6: River Gauge on Dickerson Road Bridge.

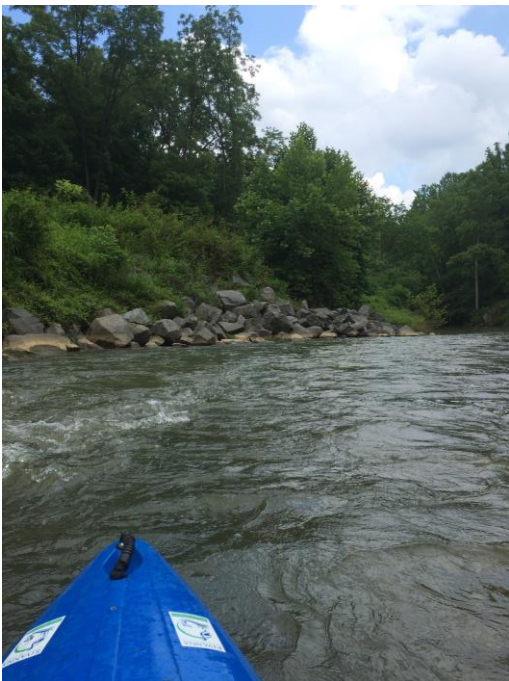
Figure 7: Manmade rock riprap near dam.

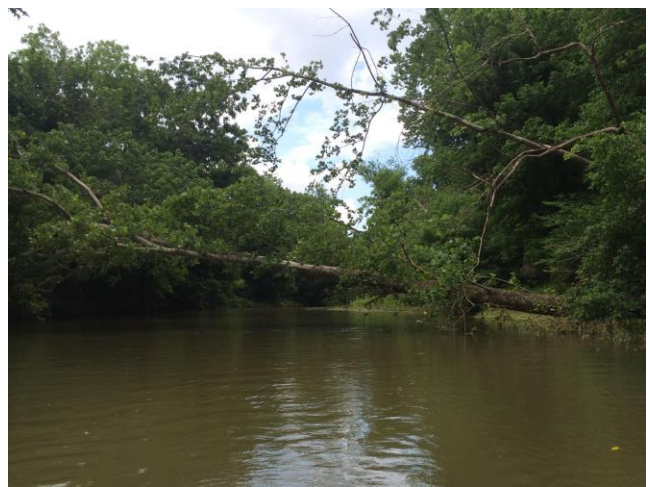
get out of my boat twice which was due to strainers blocking the way and the small dam along this stretch not water levels.

Figure 8: Tree blocking River passage.

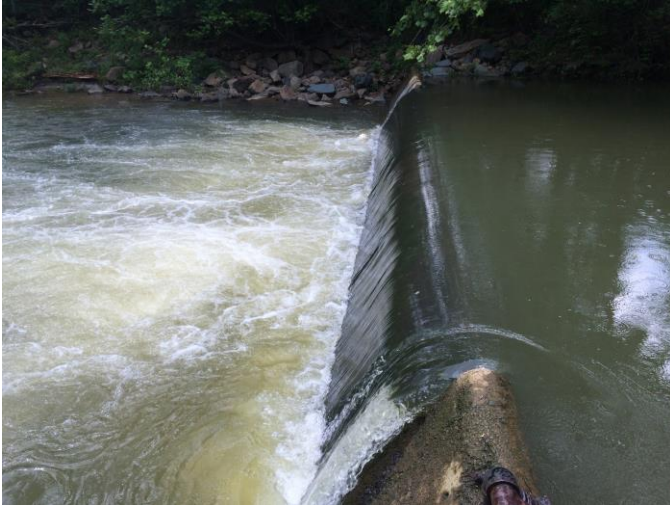
A small dam/portage is encountered near the end of the paddle. It is necessary to get out on east bank before the dam and walk down river. The dam itself has a serious undertow effect at the bottom of the 4 ft. drop that is dangerous. A few signs are placed on the banks nearby but are overgrown with foliage.

Figure 9: Small Dam where portage is required.

2 – Work to make signage more clear about dangers of dam.

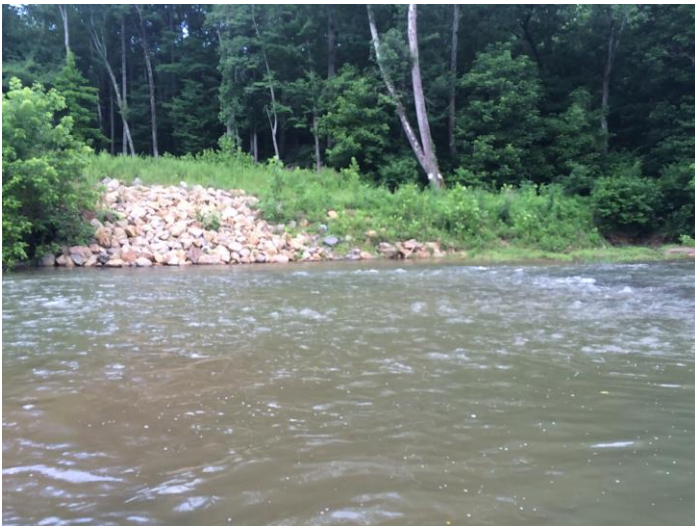
Figure 10: Finished RWSA pipe project in river near 29N pumping station.
