RIVANNA RIVER STEWARD REPORT

River Stewards: Justin Altice & Mariah Burgess

Date: 5/17/20

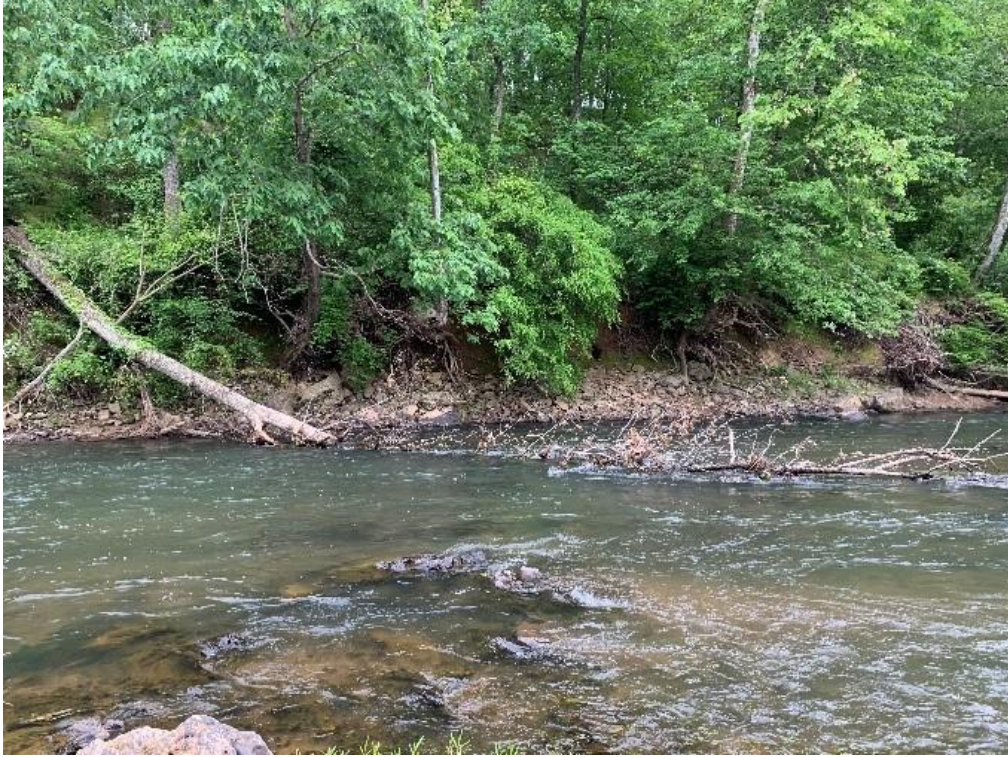
A downed tree is creating a strainer hazard on river left across from the Riverview Park takeout. See Figure 1.

Figure 1: Downed tree has created a strainer on river left. View is from center of river across from Riverview Park boat launch.

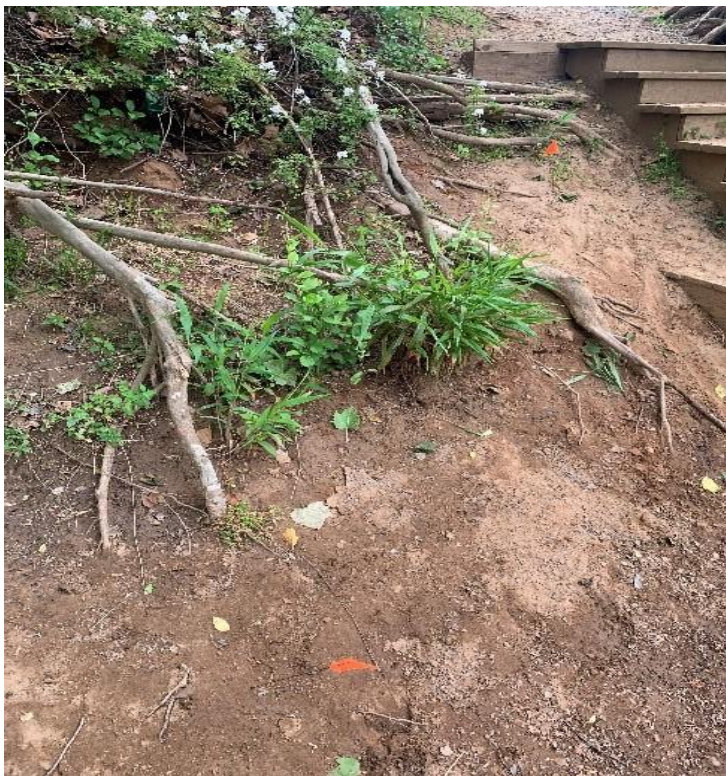
Figure 2: Orange flags signal RCA livestake planting locations at Riverview Park, some of which have been removed or damaged.

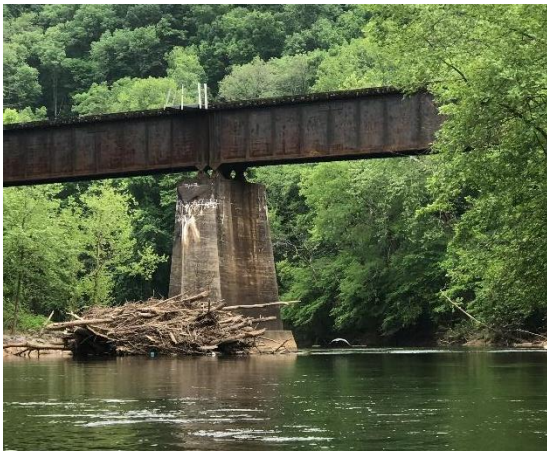
Figure 5: Blue Heron takes flight to the right of wood buildup at railroad bridge.

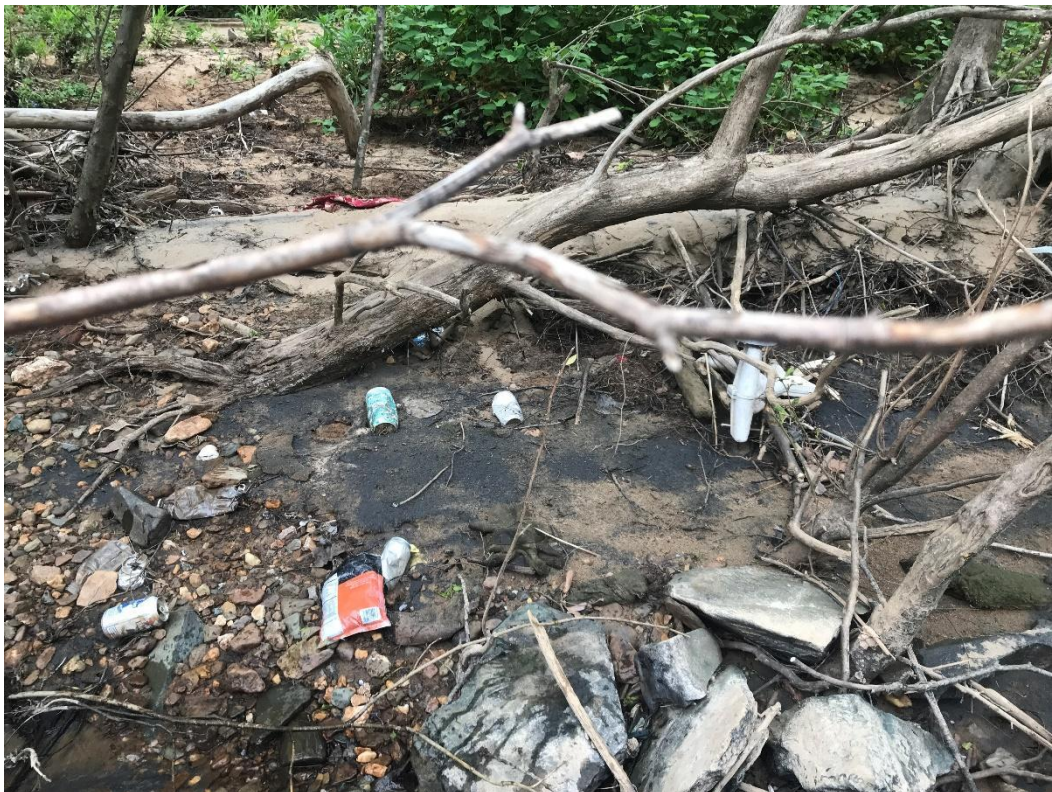
There was a significant amount of litter on the river bottom. There were several areas with trees and shrubs acting as strainers along the river banks. See Figure 8.

Figure 8: Prevalent trash observed along strainer land areas along the banks.

- 2 – Speak with community groups about conducting a Covid 19-compliant river clean up
- 3 – Work with Albemarle County and City of Charlottesville officials to collaborate on access point improvements

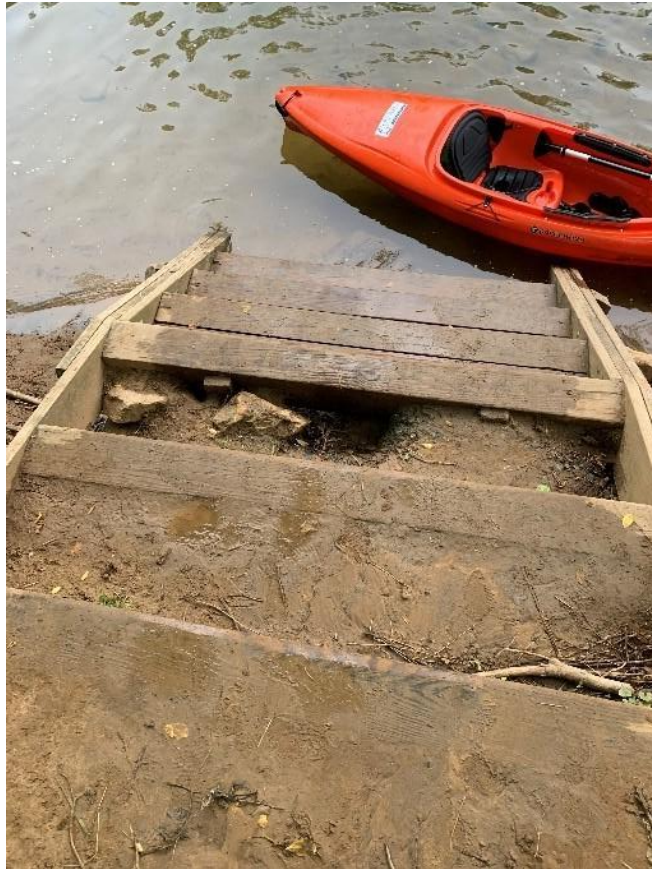
Figure 9: Milton access steps experiencing erosion that will need to be addressed to avoid creation of a hazard.
