## RIVANNA RIVER STEWARD REPORT

River Stewards: Dan Triman Date: 05-07-17

Starting Location and Time: North Fork – 29 Bridge (9:30 AM)

Ending Location and Time: North Fork – Proffit Rd (1:30 PM)

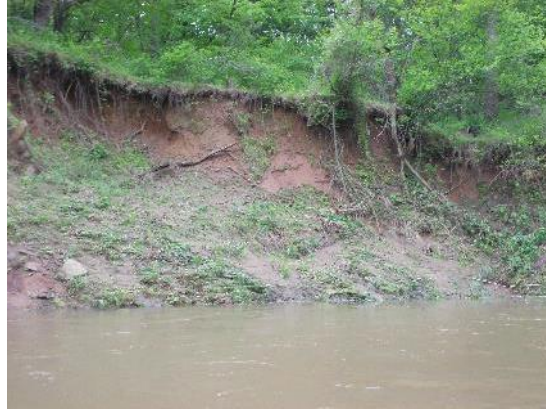
Ducks, Sandpipers, Kingfisher, 3 River Otters, Geese, Dragonflies, Butterflies, Spiders, and Crow. Many large downed trees in the water, with vegetation along banks very lush and green. Several severely eroded banks were found during the paddle, mostly on outside of curves in River.

Figure 2: Example of severely eroded bank

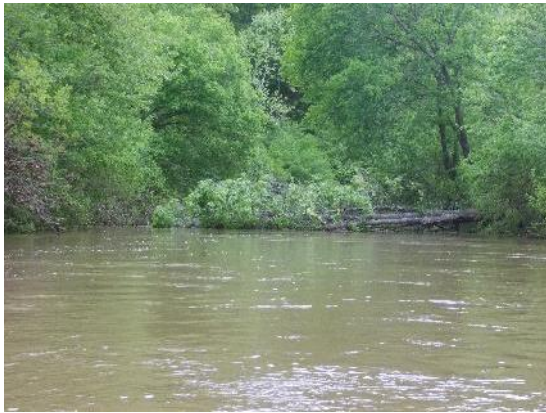
Figure 3: One of many large trees down in the River

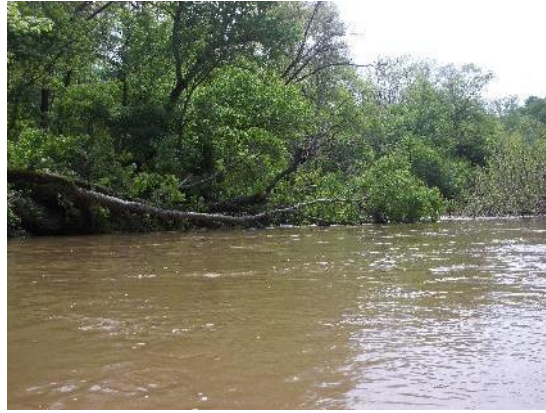
Figure 4: Another large tree down in the River

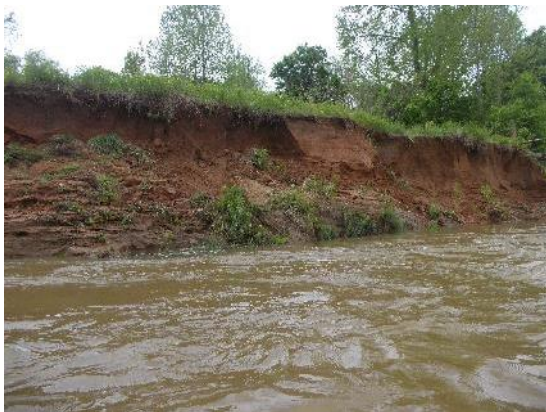
Figure 5: Another eroded bank along the River

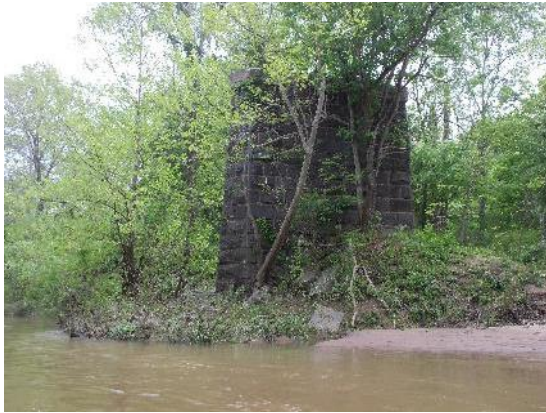
Figure 7: Bridge abutment not currently in use
