## RIVANNA RIVER STEWARD REPORT

River Stewards: Dan Triman Date: 05-29-17

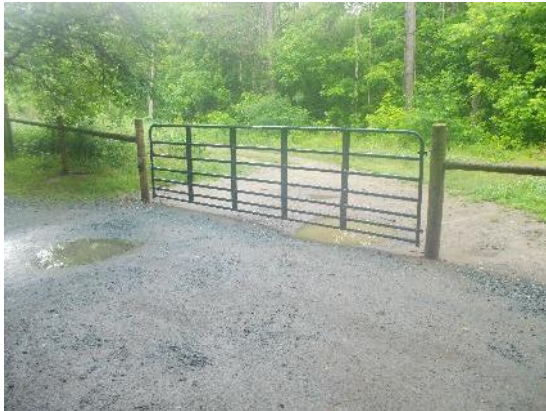
With the recent rains, the water level being up and moving pretty fast meant the trip took much less time than usual, and the majority of the rocks that can cause issues were under water. The water levels being up allowed us to paddle a little ways upstream on Mechunk Creek as well. Happy to see a new gate/fence was up at Milton to keep people from driving onto the dirt path that is causing erosion of the boat access steps.

Figure 1: New gate / fence at Milton

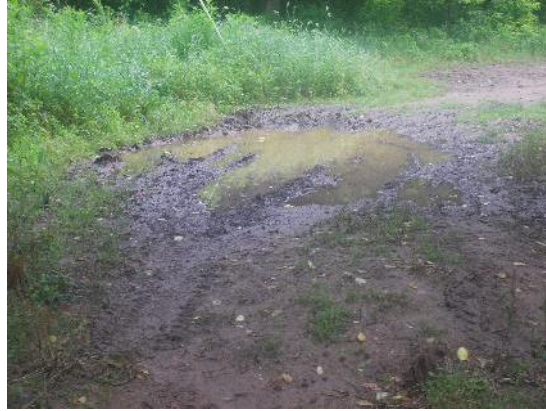
Figure 2: Dirt road at Milton boat access

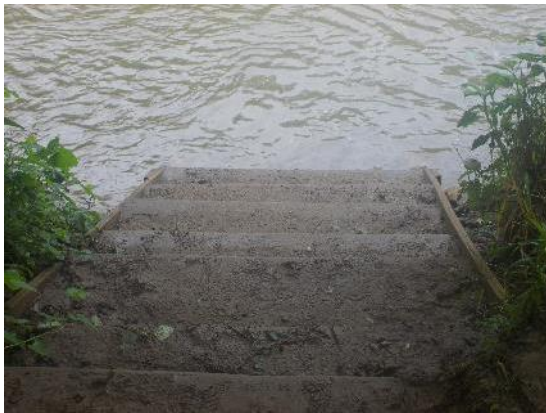
Figure 3: Milton boat access steps into the River

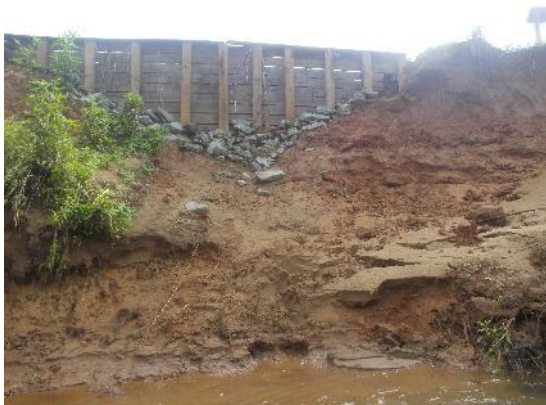
Figure 5: Erosion of bank at Glenmore

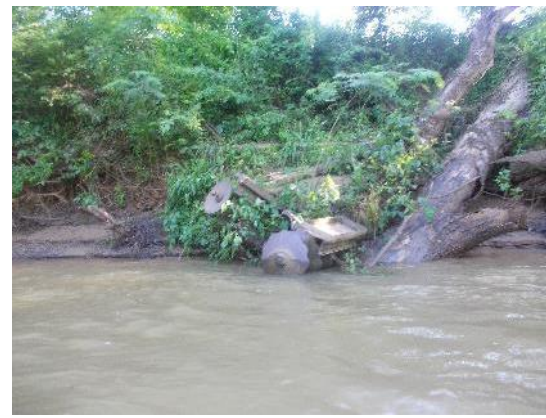
Figure 6: Large piece of farm equipment on the bank

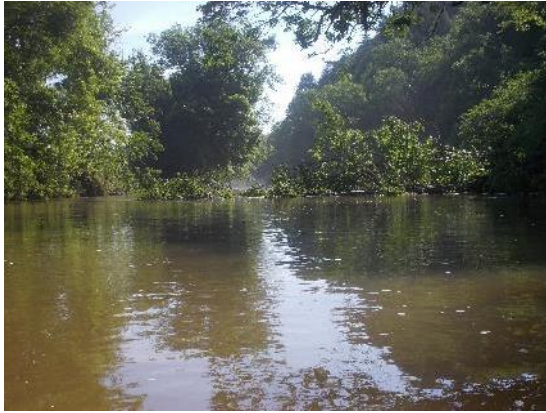
Figure 7: Tree down across the River

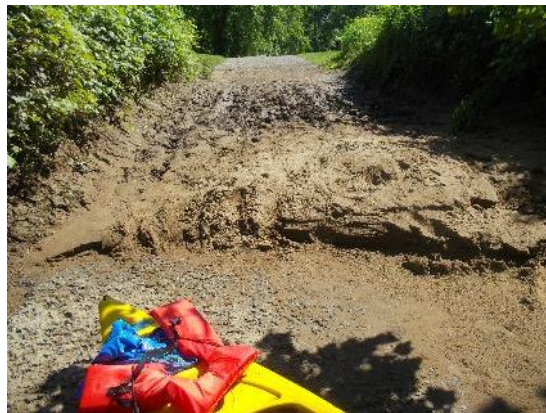
Figure 10: Sediment on Crofton boat ramp

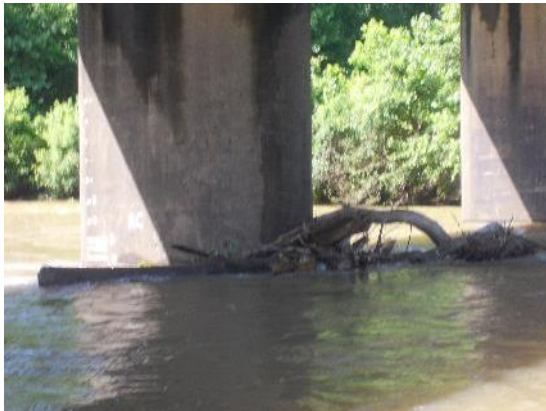
Figure 11: Trees piled up at Crofton bridge abutment

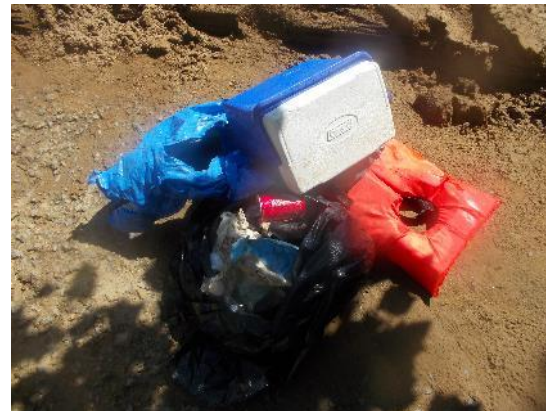
The majority of the trash found today was plastic bags stuck in the tree branches above the River. We also found a cooler, a PFD, and an inner tube we removed. Less trash found the closer we got to Crofton.

Figure 12: Trash collected during the paddle
