# RIVANNA RIVER STEWARD REPORT

River Stewards: Justin Altice & Mariah Burgess

Date: 6/8/20

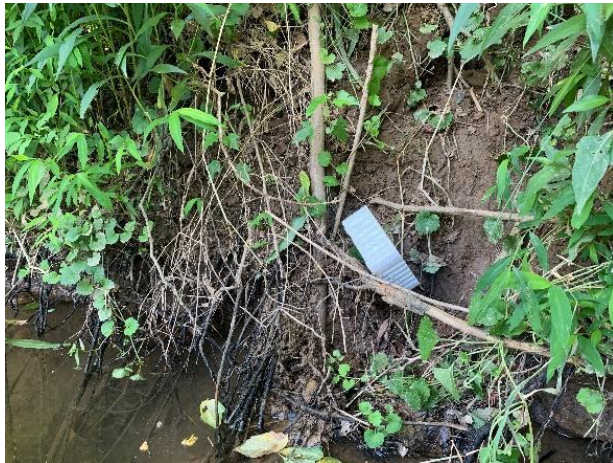
We found styrofoam bait boxes and beer cans just below the Reas Ford bridge put in.

Figure 2: Several bait boxes were along the bank, as well as beer cans

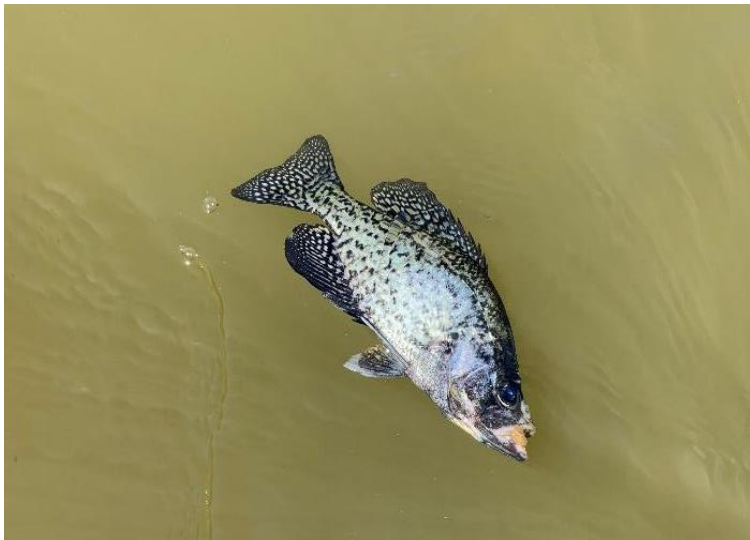
Figure 6: Dead crappie in the reservoir

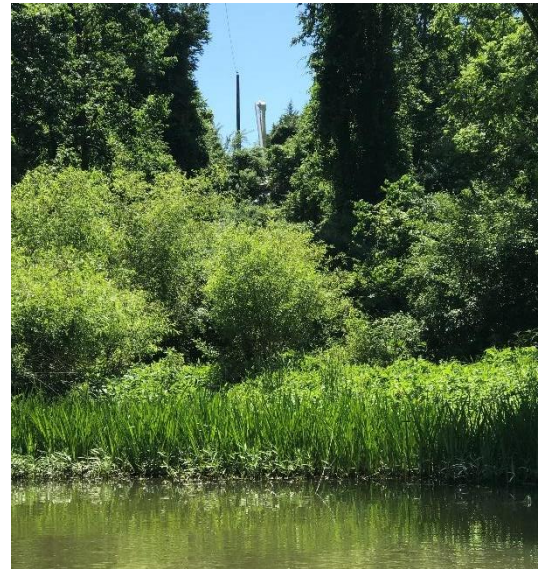
We observed that the downed utility line we reported from our 3/26/20 paddle was still in the reservoir. The utility company was working in the area, but we were unable to determine if they were working to remove the line from the water.

Figure 7: Utility company seen working near downed line previously reported and still in the water.

4 – Follow up with utility company about downed line previously reported
